September 24, 2008

## Pratt Hall, The Montgomery Historical Society

Montgomery, Vermont

### A Preservation Trust of Vermont Technical Assistance Report

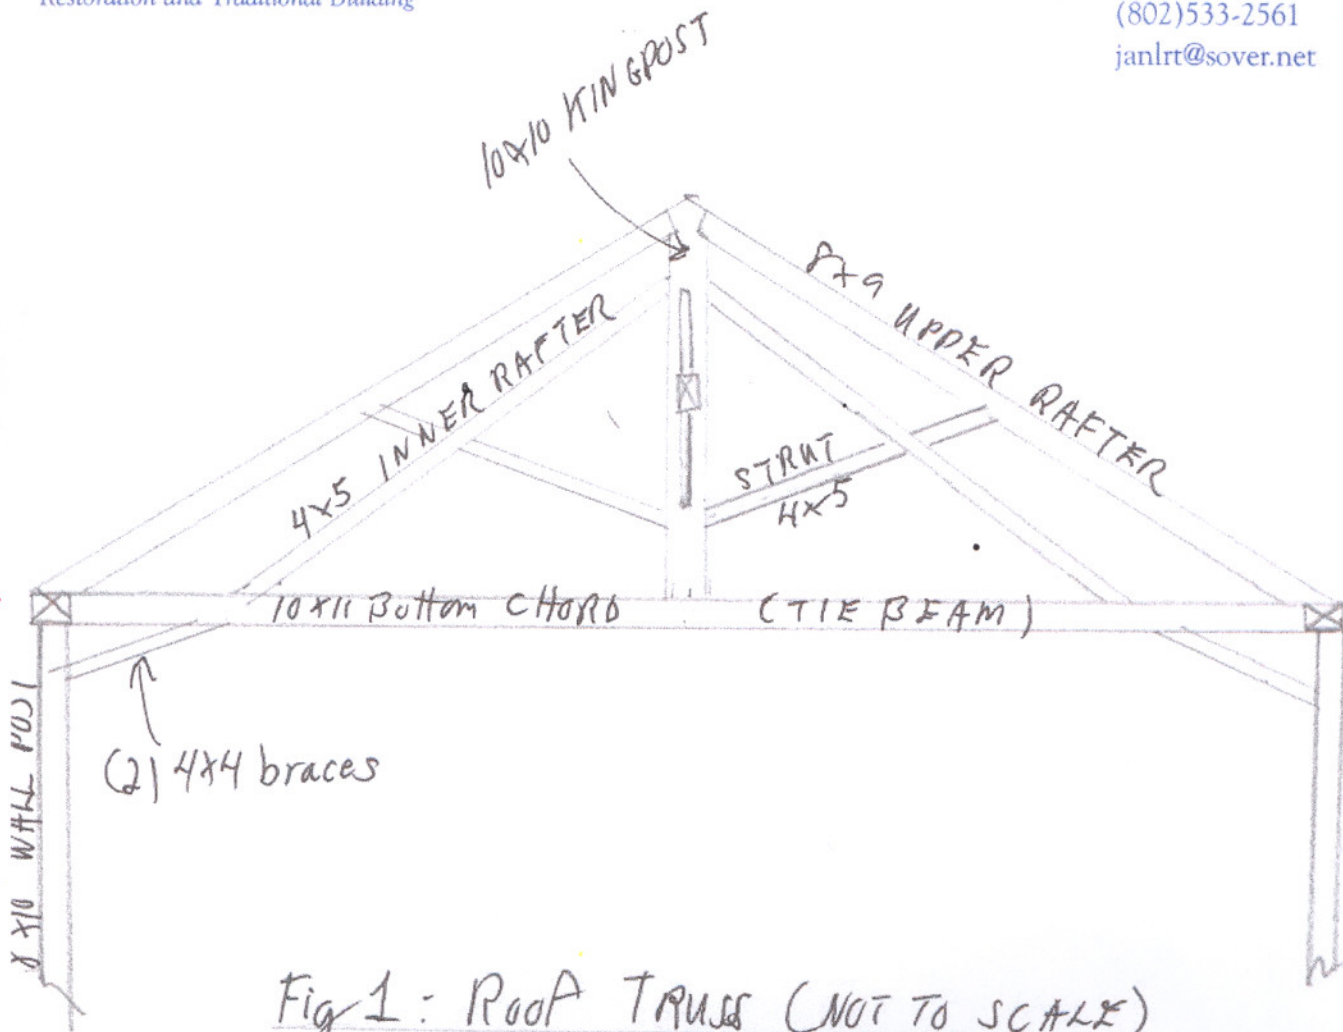
Fig 1: Roof Truss (NOT TO SCALE)

Foundation problems on the south lead, long ago, to concrete being formed and poured against the rubble stone wall on the outside, producing an exterior concrete shelf that introduces water into the sill. Right now, buckling of clapboards all along this wall indicated that the wall posts are crushing into this sill. Examined from within, the sill appears good, except that it is unusually deflecting over some stones, meaning that it is likely rotted to the outside.

Contributing to the rotting of this sill was a long time roof leakage problem along the middle of this wall. In addition to draining water all the way down to the sill, it caused the rot of at least 2 mid wall posts, and the tenons and bearing of their double braces, and the rot and disconnecting of at least 3 truss bottom chords where they meet the south wall posts. There may be plate damage as well at these joints. The 2<sup>nd</sup>, 4<sup>th</sup> and 5<sup>th</sup> interior tie beam ends from the front are bad where they bear on the post and one has fallen almost 2 inches from its correct position. **This is a serious problem and expensive to fix, and it is manifesting itself not only in buckled clapboard but in distortion of the frame of the mid south stained glass window, some uplift of the roof eaves, and subtle openings and curves developing near there in the coffered ceiling. Left unrepaired, the posts will continue to sink and tie beams to sag until real damage to the windows and ceiling occur. (see Fig. 1)**

The solution to this problem involves opening a large section of the mid south wall, jacking the posts until they are level, and, using structural scaffolding and small holes in the interior ceiling, jacking the 3 or 4 depressed tie beam ends back to their correct height. Any structural scaffolding within the nave must rest on flooring cribbed from the basement. When this is done, replace two wall posts, approximately 8 x 10 x 20 ft. spruce timbers, in their entirety, engaging and repairing or replacing all the surrounding joinery that entered these posts. (It may be possible to do this without disturbing the interior plaster and sheetrock but possibly not) The bad tie beam ends can have scarfed repairs and then be sistered with 3" plank or LVLs to midspan near the kingpost. I normally do not recommend partial truss chord replacement, but there are so many large trusses over such a short span, none of them carrying the steeple load, that I feel it can be safely done at this church. Also, any joint in tie beam can be suspended by a steel rod dropping from the upper rafter at the point where the strut rising from the kingpost meets it. Finally replace all the bad sill along this wall in solid softwood timber of the same size as the original.

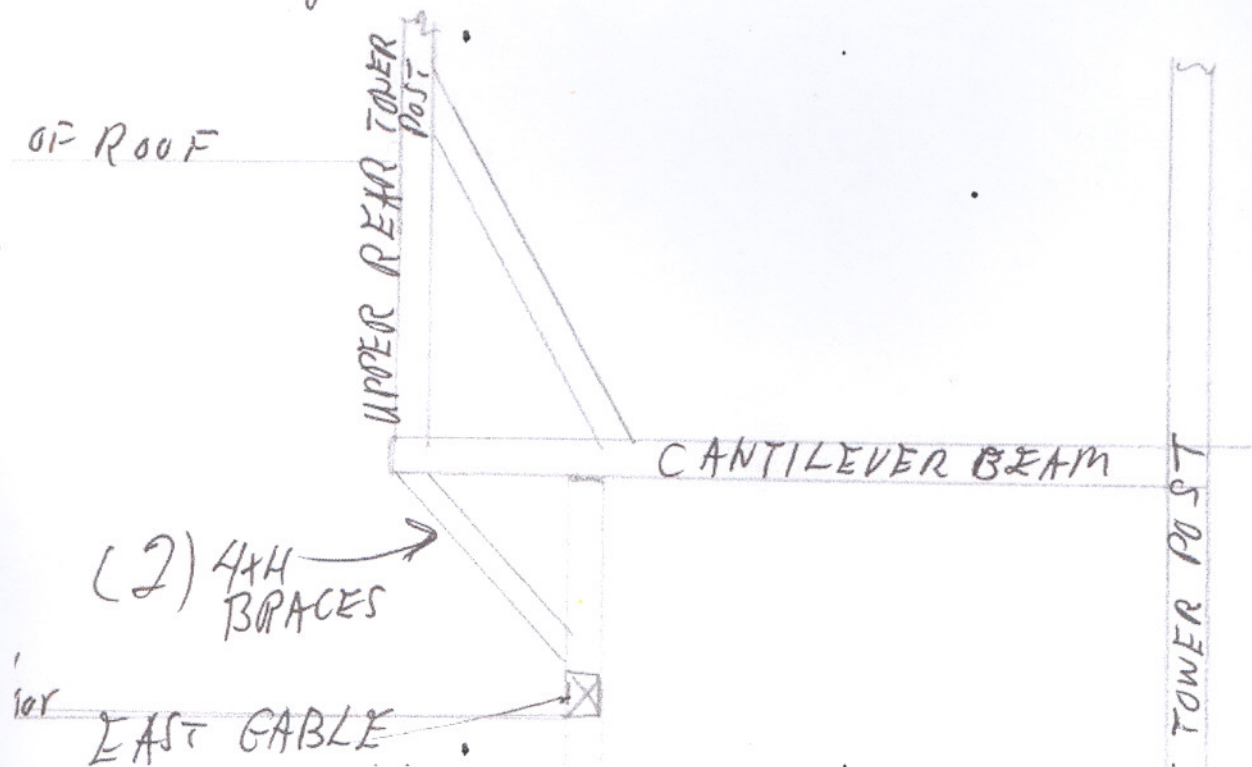
Fig 2

The frame of the tower suffered severe water damage and rot in the past and is now much altered and augmented. Originally four tall 10x 10 posts, 2 at the front tower corners, and 2 slightly less tall rising from the front sill of the nave at the tower corners formed the basis of the tower frame. The two rear posts carried a girt from the front posts that cantilevered across them, and, with the help of a pair of rising 4 x 4 diagonal braces, continued 4 ft. into the attic space of the church. A post rises from the ends of these hammer- type beams and forms the rear wall of this first, tall stage of the tower. Additional large dimension braces rise from the lower rear posts to assist this cantilevered rear wall frame to remain erect, with good success. This rear system remains largely intact although augmented with steel truss rods. The front wall posts became severely rotted in

the past and were largely abandoned sometime in the 20<sup>th</sup> century in favor of two large verticals laminated of 2 x12 plank rising to the full height of the first tower. Other built up beams run from the rear wall, cross the forward laminated posts and holds up, in cantilever fashion the front wall of the tower. The symmetry of the old rear and the new front cantilevered structural systems can only be wondered at. The new support for the front of the tower is a confusing mass of nailed, bolted and screwed planks and timbers; redundant, but there is so much of it that the tower is probably stable and need not be considered a priority except for its rotted front sill, which it hangs above anyhow.

ORIGINAL  
TOWER  
HAMM  
BEAM  
DESIGN
