Re: Historic Sites and Structures Survey of Montgomery

Criteria for listing on the State Register of Historic Places

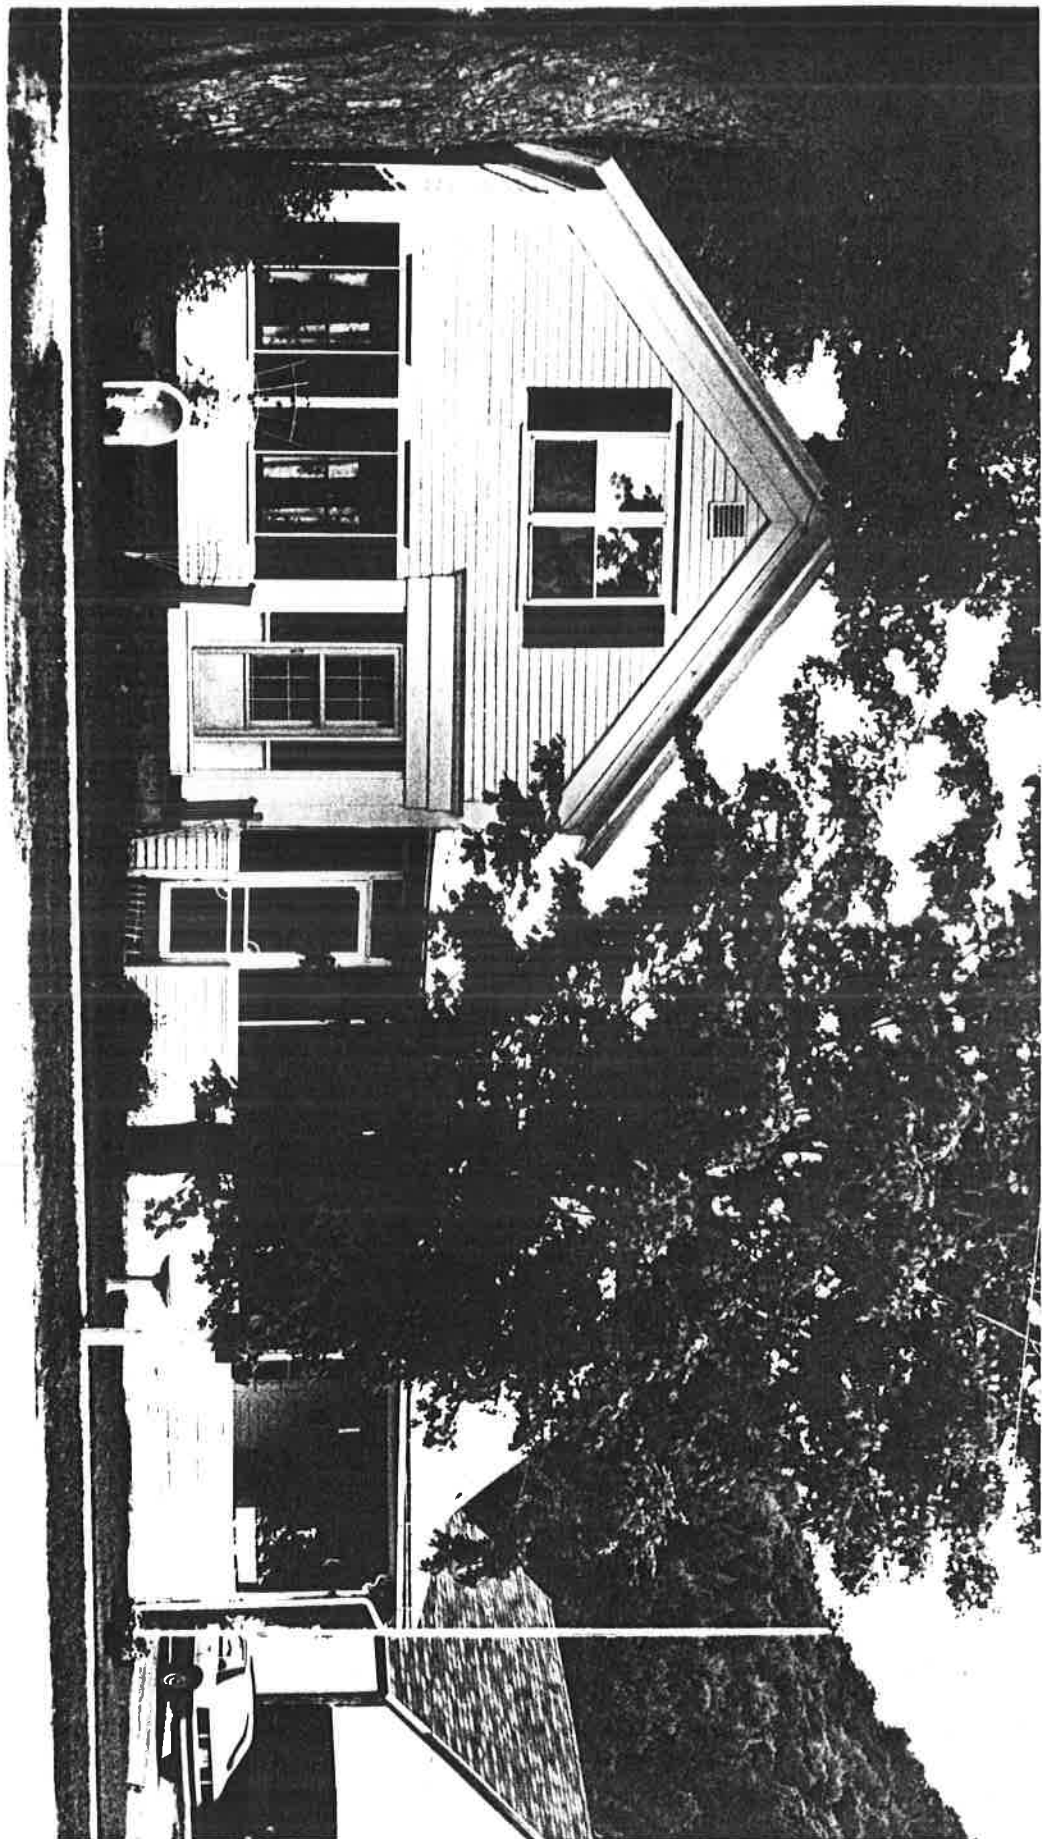
#5

MAP NUMBER: 5	DATE BUILT: c.1855	SURVEY NUMBER: 0610-1
FUNCTIONAL TYPE: House	NEGATIVE FILE NUMBER: 83-A-185	
COMMON NAME:	OWNER: Margaret St. Onge/Marilyn McBride	
DESCRIPTION: A vernacular Greek Revival house, sidehall type, with a 1½ story gabled ell (c.1880). The ell has a full-length, partially enclosed porch (c.1920) and a one-story gabled ell/woodshed (late 1800's). The entrance of the main unit is given special significance by its heavy Classical detailing. It consists of a door (multi-paned glass replacement) flanked by three-quarter length sidelights with recessed panels. Broad unmolded pilasters support a similarly broad entablature with a plain frieze and a narrow flat mold cornice. Other stylistic details include: flat molded cornice with wide plain frieze and wide cornerboards; 1/1 sash with plain surrounds and a thin flat molded cornice cap. The ell is detailed with a flat molded cornice and cornerboards; 1/1 sash with plain surrounds and a thin flat molded cornice cap. (One 6/6 sash is located in the
